# An Evaluation of the Effectiveness of Swareflex™ Deer Reflectors

Ministry  
of  
Transportation

Research and  
Development  
Branch

March 1992

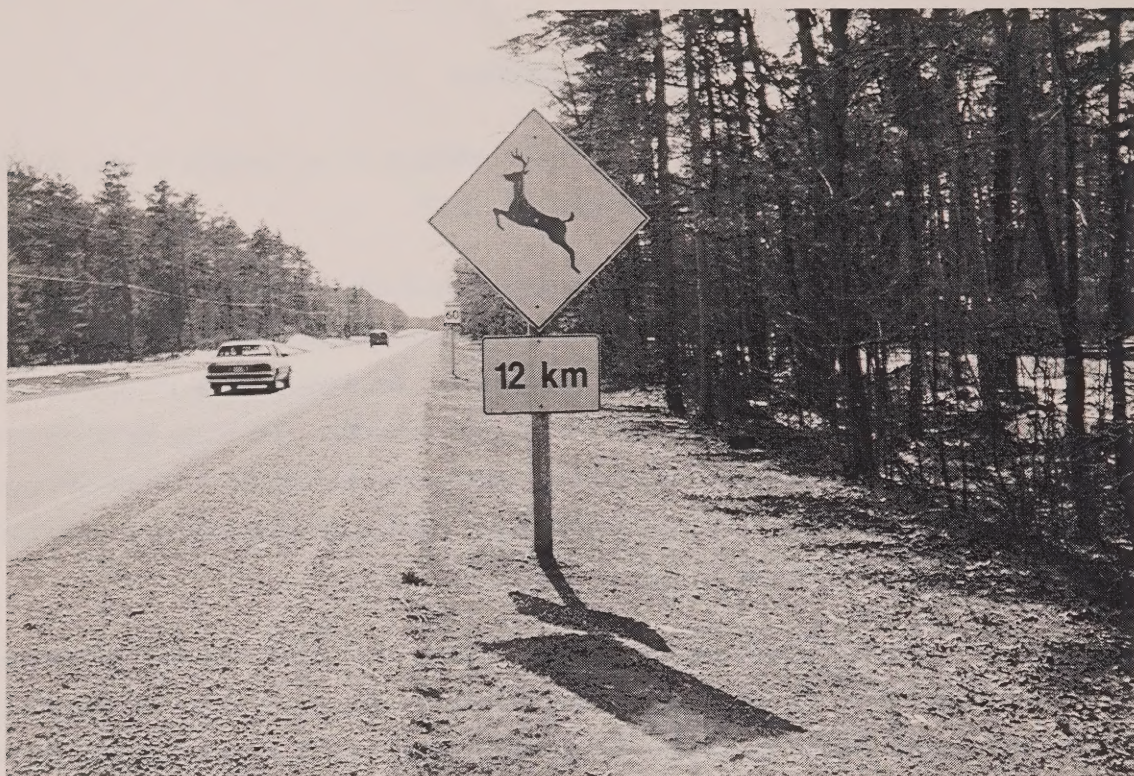
Figure 1/ Example of Ministry leaping deer sign

The standard approach used by transportation departments, including the Ministry of Transportation of Ontario (MTO), to control deer/vehicle accidents has been the placement of two sizes of "leaping deer" signs along both sides of the highway (Figures 1, 2). An alternative is the installation of reflectors claimed to modify deer's behaviour in the presence of traffic. This study tested Swareflex, the reflector manufactured by D. Swarovski and Co., Austria and distributed in North America by Strieter Corp. of Rock Island, Illinois, USA. The distributor and the manufacturer claim outstanding results in Europe and North America.

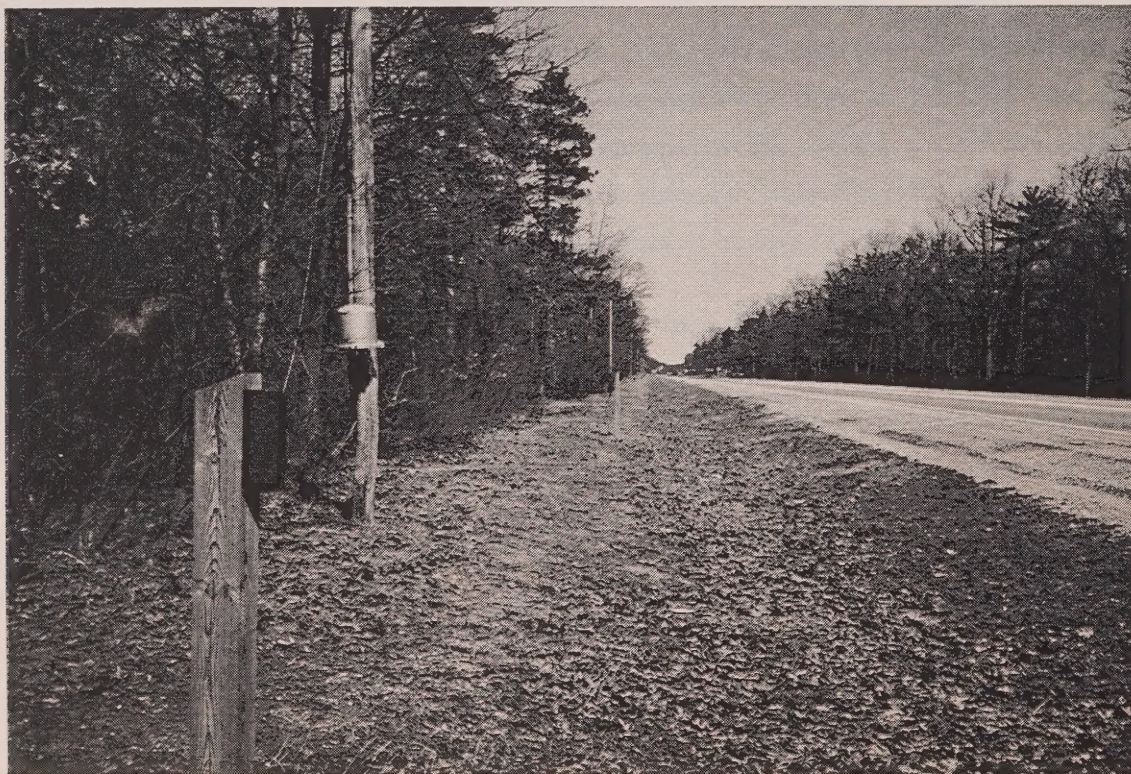
Figure 2/ Swareflex reflector mounted beside Highway 21

Swareflex reflectors were installed on both sides of Highway 21 in August, 1990. Two configurations were used, both recommended in the Manufacturer's installation instructions for the field conditions existing in the study area. In one configuration, the triangular reflectors were fastened to the 2 m, 10.16 cm square cedar posts 1 m from the ground. The posts were placed 14.5 m apart at the edge of rounding on

In both configurations, the apex of the triangular reflectors was placed so that the two reflecting surfaces were directed towards the road. Thus, the lights of an approaching vehicle would strike the reflector, be reflected across the road and appear to travel in the same direction as the vehicle. Light from the same vehicle, striking reflectors placed on the opposite side of the road, would tend to behave in the same manner. The alleged effect is to delay or even suppress the deer's passage onto the highway.
